REPRESENTATIVENESS OF SMALL COUPONS FOR CORROSION OF LARGE PLATES

Robert E Melchers, Robert J Jeffrey and Goran Simundic Centre for Infrastructure Performance and Reliability The University of Newcastle, Australia

SUMMARY: Earlier work (Melchers and Jeffrey 2002) showed that coupon size and shape was not a major contributor to the variability in corrosion loss estimates. However these conclusions were based on the relatively small coupons used typically in corrosion field studies. In order to estimate whether such small coupons produced realistic results for much larger plates, mild steel plates 1.2 m x 0.8 m x 3mm thick were exposed for up to 2.5 years in immersion, tidal and splash zone conditions at Taylors Beach, NSW. The plates were recovered at 6, 12, 18, 24 and 30 months. At each stage the plates recovered were cleaned, dried and guillotined into 12 equal rectangles suitable for fitting into a mechanical 3D scanner. The digitised scan results show a high degree of similarity of corrosion across a surface, and a similar pattern of corrosion loss with time of exposure. Estimates for variability of corrosion loss were made from the digitized data. Differences between immersio

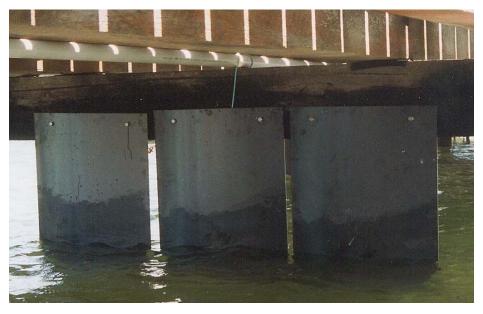
Figure 2. Steel plates immediately after being suspended under jetty at Taylors Beach, at low tide, showing clean surfaces.

Each plate measured 1200 mm x 600 mm x 3mm thick and was commercial quality low carbon steel from the same batch. Five of the plates were suspended with nylon ropes from a piled rig located mid-estuary at a site sufficiently deep to ensure immersion conditions throughout the year. The other five plates were suspended vertically under a local timber jetty (Figure 2). Two holes were drilled in each plate to enable suspension. Practicalities dictated that all plates were exposed in the 'as received' condition.

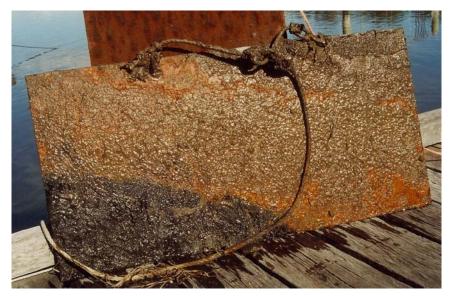
Figure 4. Plate recovered from mid-estuary at 12 months exposure. The inclined pattern (at lower left) was caused by a failure of the suspension system such that the corner of the plate entered the local mud. The distinctly different external rusts are clearly visible.

A plate from each set was recovered at 6, 12, 18, 24 and 30 months from first immersion. After 6 months there was already considerable corrosion in evidence, as seen in Figure 3 for three of the plates under the jetty. Figure 4 shows a plate after 12 months exposure. This plate had tilted from its originally horizontal fixing position, as evident from the black area (lower right) where the corner of the plate had buried into the mud.

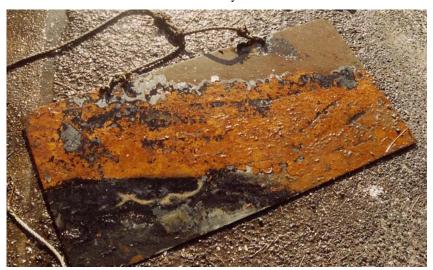
Figure 5. The plate in Figure 4 immediately after washing with high pressure water, showing some regions of bright metal in the transition zones between mud and tidal and splash zones.

Immediately after recovery and photography the plates were washed with a high-pressure hose to remove marine growth and loose rusts. Figure 5 shows the plate in Figure 4 after washing. Typically this revealed a rather regular undulating surface texture over most of the plate surface (Figure 6). After one year exposure most plates revealed some areas of bright steel surface that began to tarnish almost immediately upon exposure to air.

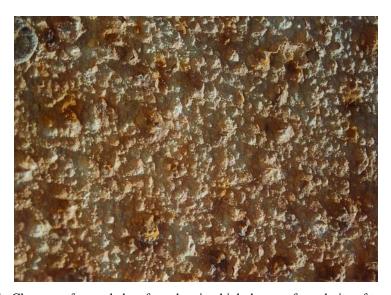
Figure 6. Close-up of corroded surface showing high degree of regularity of topography.

Figure 10 shows an example of the power spectra for the splash zone with the data normalised to zero means. In each case the frequencies with most power are very restricted. Along each of the two horizontal axes f_1 and f_2) the frequencies with the most power are those around 0.1 cycles/mm, with only minor effects elsewhere. This implies that there is a high degree of uniformity or regularity in the profile of each of the surfaces, as is indeed evident form visual inspection (Figure 6), and
