Aspects of long-term durability of reinforced concrete structures in marine environments

Robert E Melchers – Torill Pape

*Centre for Infrastructure Performance and Reliability,
The University of Newcastle, Australia.
rob.melchers@newcastle.edu.au
torill.pape@newcastle.edu.au*

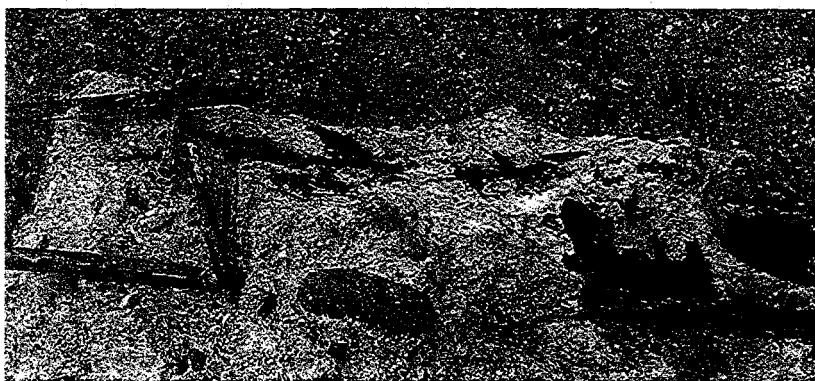
Several segments of 1943 balustrade, in good external condition, without obvious cracking, were broken open longitudinally. Mostly the reinforcement was in excellent condition and similar to when the concrete was first cast. One of the segments, however, was completely different. Part-way along the segment, one of the reinforcing bars disappeared, with only a thin black stripe remaining along the path where the reinforcing bar had been, as evident from the cavity left behind (Figure 1). Close inspection showed a very fine crack across the segment at about the location where the reinforcing bar suddenly 'disappeared'. Small areas of rust staining were observed on the concrete surfaces adjacent to the 'disappeared' bar, with appearance of dried-up puddles of rust stain (Figure 1, right).

Figure 1. Bars at left show no sign of corrosion after 65 years exposure but bar at centre top has completely corroded leaving a black trace. Note 'dried puddles' of rust stain at right.

These observations, apparently, are not atypical and had been found also for other CALs (Gary Webb, private communication 2009). When repairs were made for some of these by removal of local concrete cover, in some cases the original reinforcing bar(s) in the area were found to have been severely corroded, leaving only a trace of black corrosion product in the space(s) where the reinforcing bars had been. This is similar to what was found at Arbroath (Figure 1) and at Sorell.

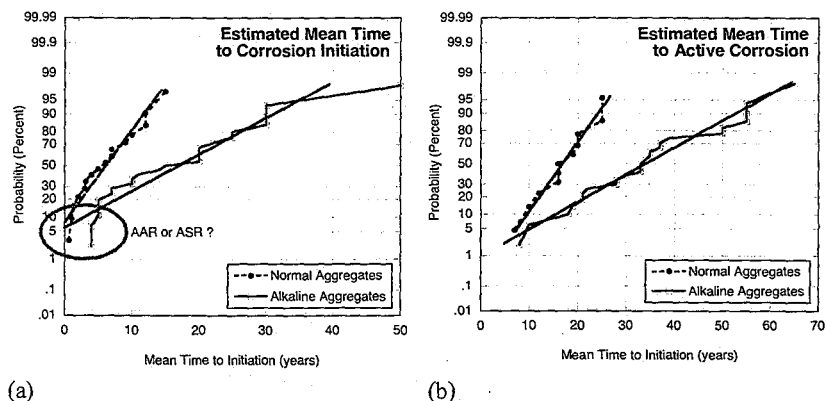
concretes with igneous or similar aggregates, (ii) concretes with limestone, dolomite or blast furnace slag aggregates and (iii) concretes made with blast furnace slag. Taking the last two together, the data are summarized on Normal distribution plots in Figure 3. These are based on 54 groups of data, some consisting of just one observation and others of up to 1000 elements. In all cases the influence of concrete mix and concrete cover, of average or range in temperature and local weather conditions was ignored and simply considered as part of the variability in the data. The severity of exposure to chlorides was considered but was only of secondary importance particularly for the time to active corrosion (Melchers and Li 2009a).

Figure 3. Normal cumulative probability plots for (a) time to initiation and (b) time to active corrosion showing normal aggregates and 'alkaline' aggregates.

The data trends in Figure 3 are in each case close to a Normal distribution. The slope of the trend line is proportional to the scatter in the data. In each case this is high, presumably because the influences of various potential factors was ignored (see above). Despite the scatter, there is a clear difference in the time to corrosion initiation for concretes made with igneous or similar non-high-alkaline aggregates and those with high levels of inherent alkalis. A large difference is seen also for the time to active corrosion. Both plots indicate that alkaline aggregates such as limestone, non-reactive dolomites, blast furnace slag and with blast furnace slag cements have a positive effect on delaying reinforcement corrosion, both its initiation and the onset of serious corrosion progression. Figure 3(a) shows also that some data may have been influenced by an alkali-aggregate or alkali-silicate reactivity of the aggregate since these reactions cause early failure of the concrete and thus fail to provide sufficient protection. Failures of these types should not be considered as belonging to the same cohort of failures as those resulting primarily from reinforcement corrosion. More details are available (Melchers and Li 2010).

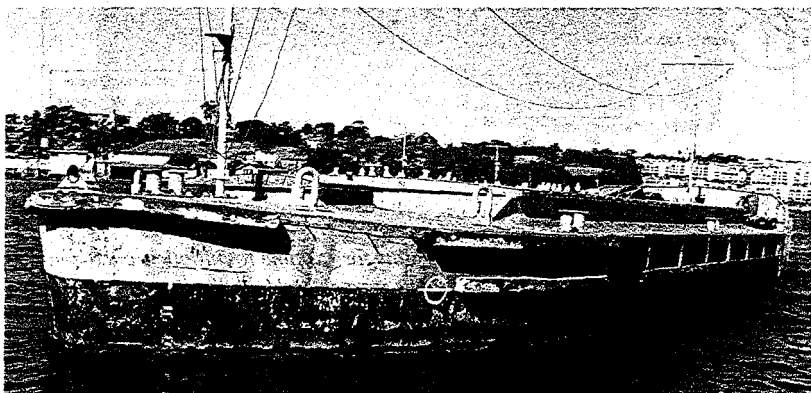
For reasons of safety reinforced concrete ammunition lighters (CALs) rather than more conventional vessels are the preferred mode of transportation for explosives and ammunition to front-line naval vessels during provisioning in port. The Australian Navy has retired a number of CALs from service and sold them on the open market. Many are still in very good condition. Many have found further use as tanks for fish-breeding and fish-farming. Six, dating from around 1970, became available for inspection during April 2009. These were 100 tonne and 200 tonne capacity and 27.7 and 32.6m long, respectively and of cast construction (Figure 4). They had operated in Sydney Harbour in waters closely similar to coastal seawater.

Figure 4. *A 100 tonne concrete ammunition lighter (CAL) in Sydney Harbour.*

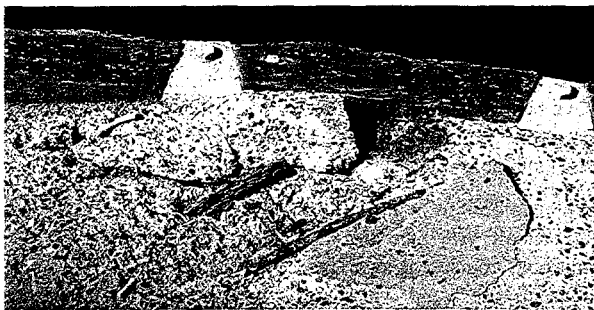
Despite having been in service for some 40 years the CALs showed almost no reinforcement corrosion externally or internally. There were one or two very small areas where the reinforcement had been exposed (Figure 5). These showed local reinforcement corrosion but negligible rust staining or corrosion-induced cracking. The internal concrete surfaces were in excellent condition and free from evidence of reinforcement corrosion, with one notable exception (Figure 6). On one of the internal surfaces, there is brown rust and rust weeping and staining. XRD (X-ray diffraction analysis) showed these to be predominantly conventional rust oxides. There is no evidence of reinforcement corrosion on the corresponding exterior hull surface, only longitudinal cracking (Figure 7).

Figure 5. *Exposed corroded reinforcement on deck showing no rust staining and carbonation of concrete.*

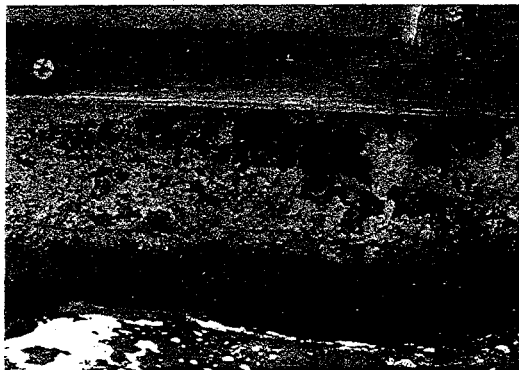
Figure 7. *Exterior of CAL corresponding to rust stained region in Figure 6. Note horizontal crack above the water line level for unloaded vessel.*
